D-Day

TANK WARFARE

ARMORED COMBAT IN THE NORMANDY CAMPAIGN JUNE-AUGUST 1944

Steven J. Zaloga and George Balin

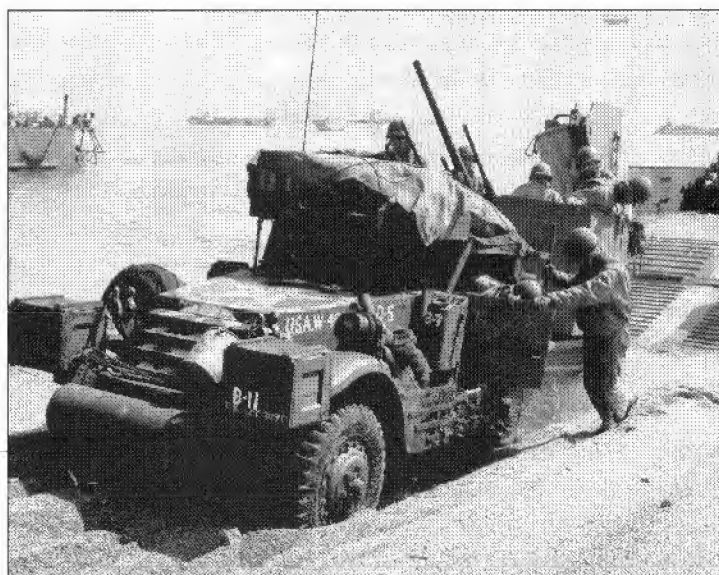
A M15A1 CGMC anti-aircraft vehicle is stuck in the soft beach sand at Slapton Sands on the English coast on 27 April 1944 during invasion exercises. The Slapton Sands exercise area was the scene of a controversial incident prior to the invasion when German E-boats managed to sink a troop-laden cargo ship, leading to heavy losses amongst the US infantry on-board. The incident was officially censored in 1944 for fear of revealing information about the forthcoming invasion, and became the source of controversy in the 1980s when relatives of the infantrymen lost in the incident tried to learn more details of the disaster. (US Army)

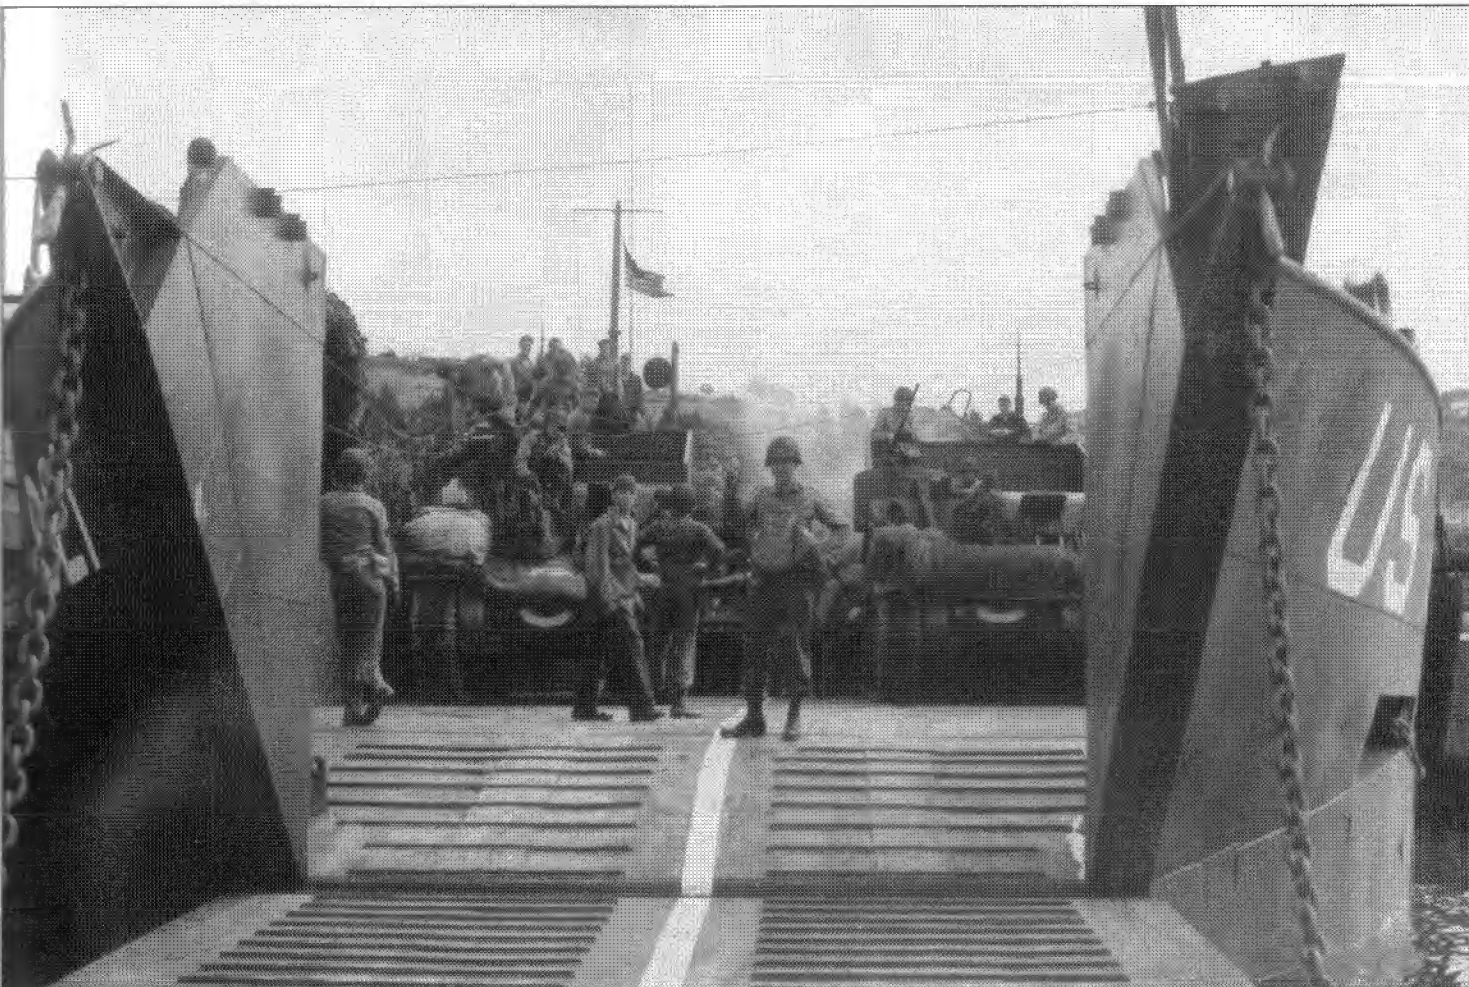
Four M10 3 inch tank destroyers are loaded aboard an LCT Mark 6, probably in Weymouth or Torquay harbor, in early June 1944. Each LCT could carry four medium tanks or their equivalents. These were the most common landing craft used in the initial assaults, with follow up landings conducted with the larger LSTs. Many of the LCTs delivering US tank units to the beaches on D-Day were manned by Royal Navy crews. (US Army)

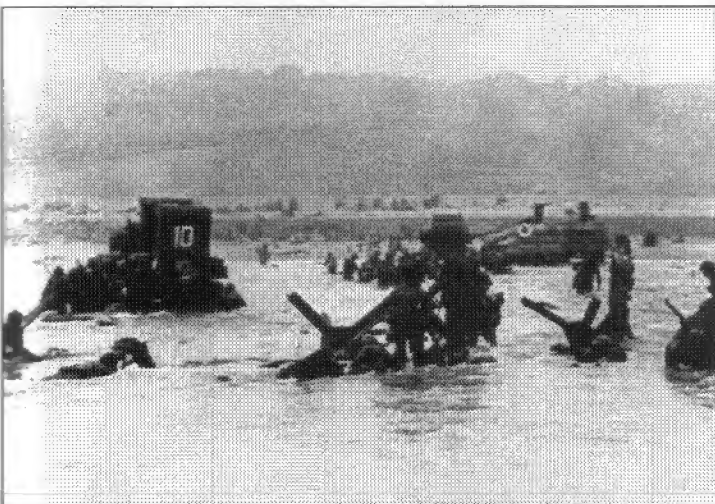
Few photos survive of the Omaha beach landings. Here is a rare shot from the morning of 6 June at Omaha beach with a M4 with deep wading trunks to the left and a M4 Duplex Drive to the right from the 741st or 743rd Tank Bn. The high escarpment that trapped the US forces on Omaha is very evident in this view. Many of the 96 tanks landed at Omaha beach were knocked out by German anti-tank guns placed in bunkers along the beach or along the escarpment. (The Tank Museum)

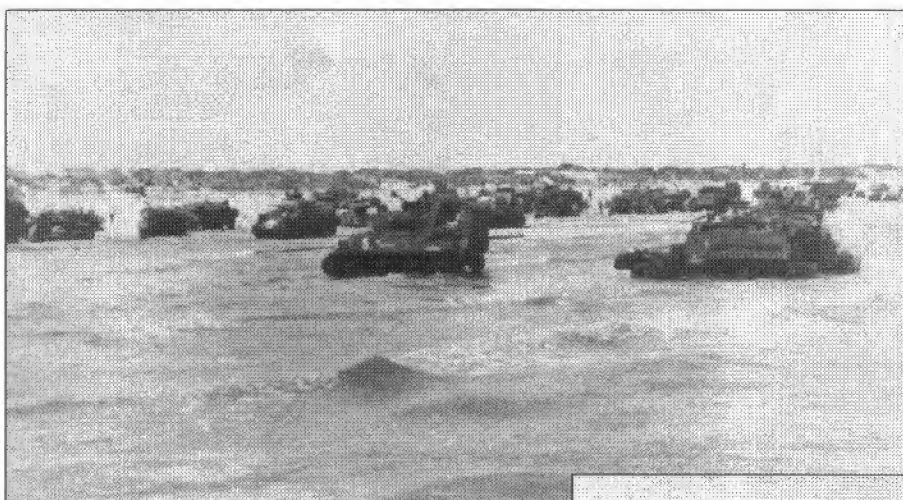
The situation at Utah beach was not as desperate as at Omaha. Here, Company C of the 70th Tank Bn. lands with their M4s, fitted with deep wading trunks. In contrast to Omaha beach, notice the lack of a high escarpment beyond the beach, a geographic detail which greatly effected the course of the fighting. (US Army)

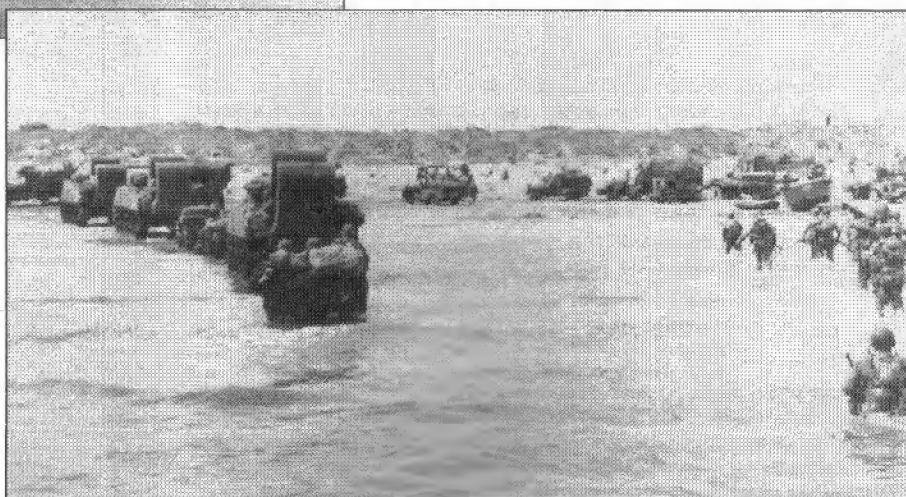
One of the few detailed photos to have survived of a US tank from D-Day is this view of "Cannonball", a M4 medium tank with deep wading trunks of Company C, 70th Tank Bn. that became trapped in a tidal pool at Utah beach during the landing. The large red numbers with white trim were a characteristic marking of this unit. (US Navy)

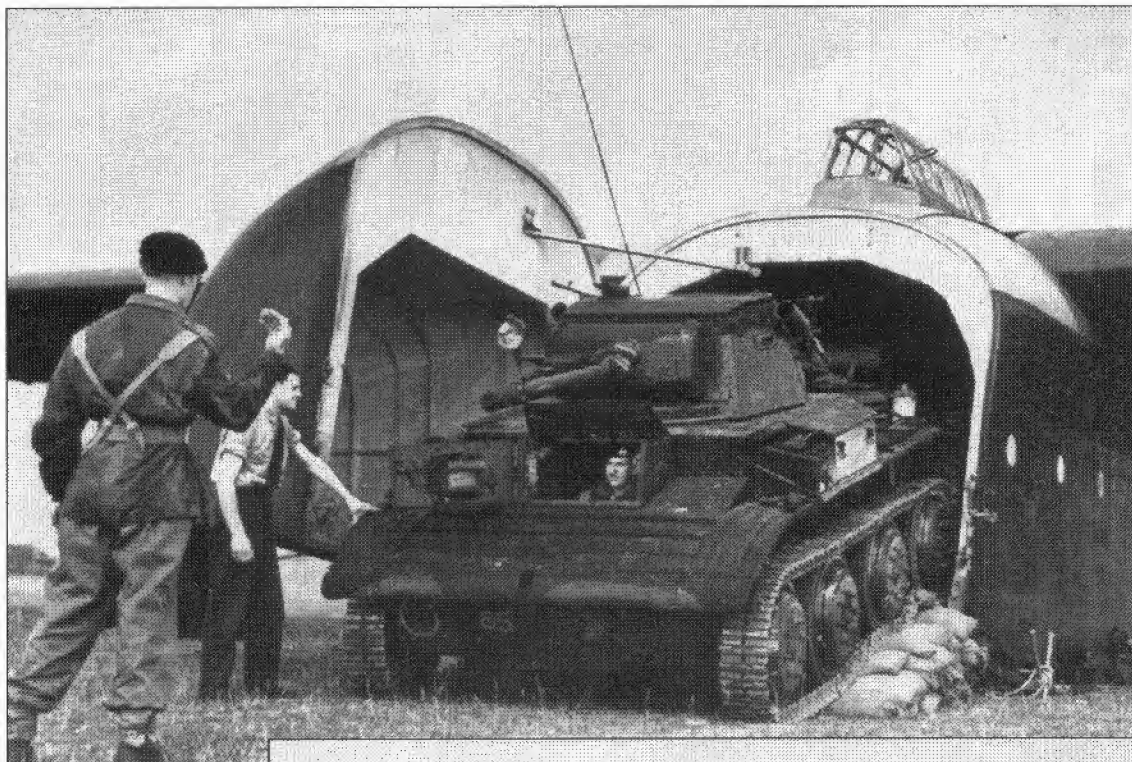
One of the most curious tanks taking part during D-Day were the eight Tetrarch light airborne tanks of the British 6th Airborne Recce Regt., 6th Airborne Division which landed in the second wave on the evening of D-Day on Hamilcar gliders to help the paratroopers seize the Orne river crossings. This is "Ritz", a Tetrarch Mk. 1CS of the HQ section, which was armed with a 3 inch gun for close support instead of the usual 2 pdr. This photo was taken during training prior to the landings. The Tetrarchs were not very effective during the operation, as their suspensions tended to become ensnared by the tough nylon parachute suspension lines that littered the landing zone. They were later replaced with Cromwell tanks. (The Tank Museum)

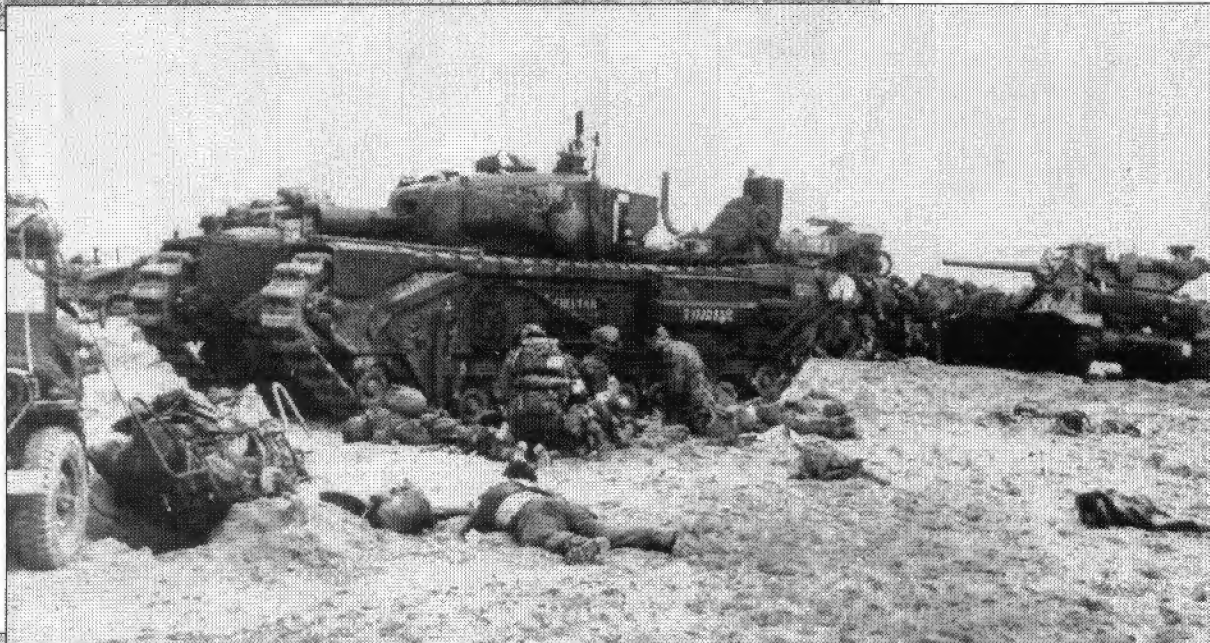
A Churchill IV AVRE named "Cheetah" of the 79th Armoured Division provides shelter for troops of the 2nd East Yorkshire on Sword Beach during a German artillery bombardment on D-Day. In the background are a pair of M10 Achilles Mk. II. Known as "Hobart's Funnies", the 79th Armoured Division provided much of the specialized armor used by British forces on D-Day to assist in the landing. (The Tank Museum)

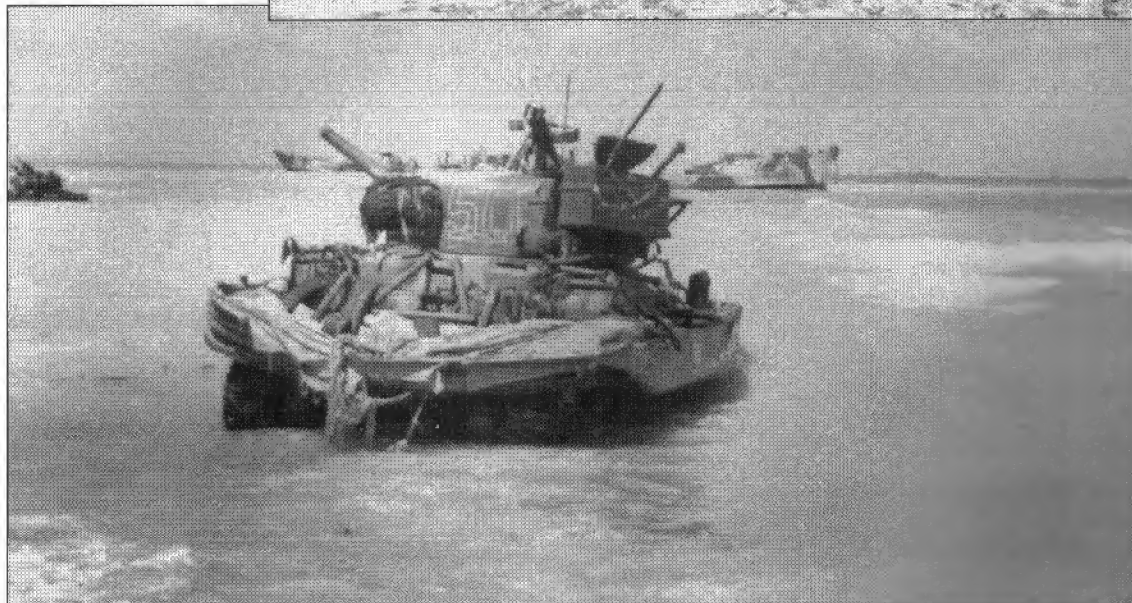
This Sherman II Duplex Drive of the 13/18th Hussars almost made it all the way to shore on D-Day, but got stopped short at Sword Beach. The Duplex Drive consisted of a canvas skirt around the tank which made it bouyant, combined with a pair of propellers at the rear for propulsion. In this view, the screens are collapsed, showing the rubber inner tubes that helped keep the swimming skin erect. This tank is marked with a large white Allied star on the turret roof, and large, two-digit tactical numbers on the turret side. (The Tank Museum)

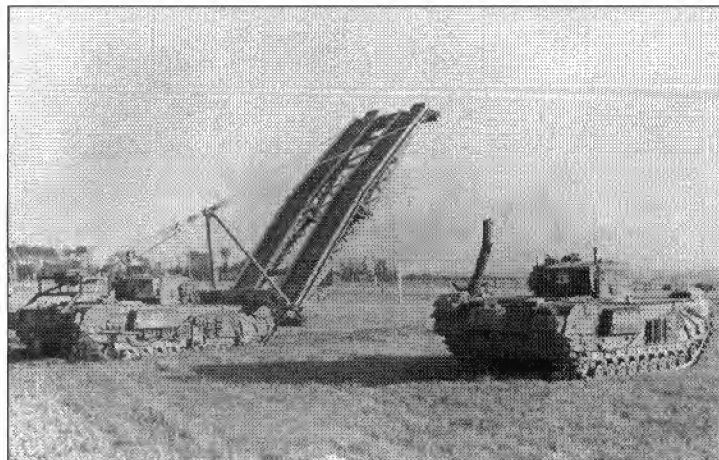
A view of a Churchill AVRE of the 222 Assault Sqd., 42nd Assault Regt., 79th Arm'd Division with the SBG fitted at the front. The SBG was designed to cover anti-tank ditches or other beach obstructions; a small roll of fascines was carried at the front of the tank that was dropped at the lip of the SBG to help tanks mount it. This photo was taken in September 1944 when the Funnies were supporting operations near Le Havre. (The Tank Museum)

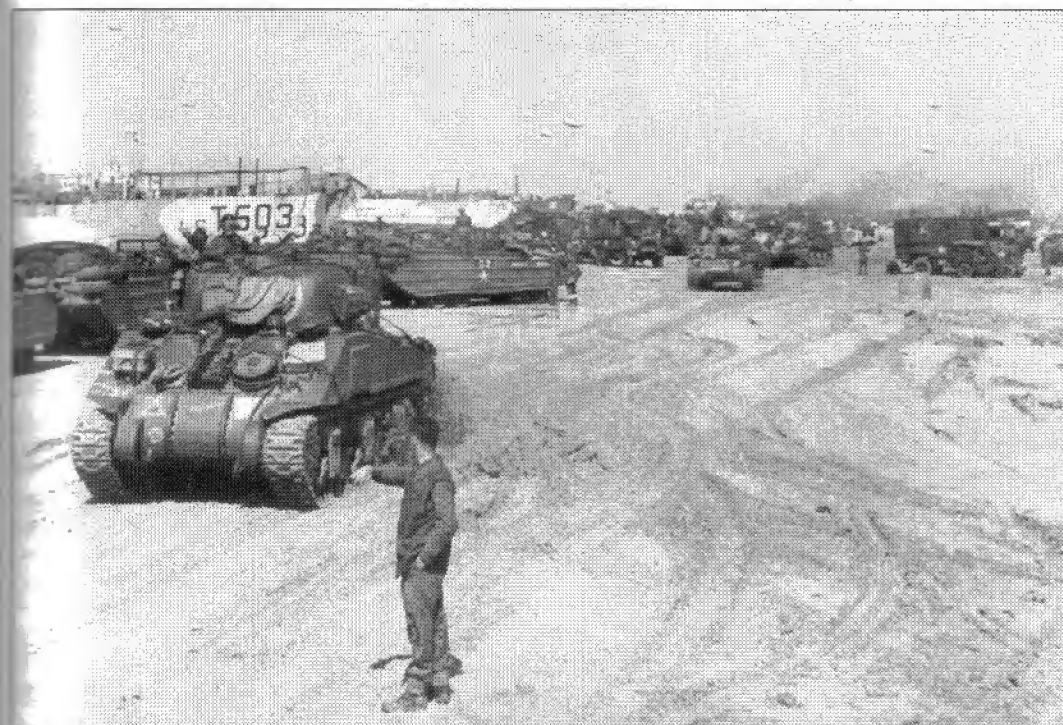
A column of Shermans of A Squadron, 24th Lancers moves off Gold Beach on D-Day with many DUKWs in the background. The 24th Lancers were part of the 8th Arm'd Bde., which provided tank support to the 50 Div Group at Gold Beach. The lead vehicle here, named *Armageddon*, has had part of its wading trunks removed but still retains the canvas waterproofing over the main gun. Units markings evident on the front of the tank include the triangle (indicating A Squadron) with a yellow bridging circle below, the tank name on the center of the transmission housing, and the brigade insignia above the right stub fender. (The Tank Museum)

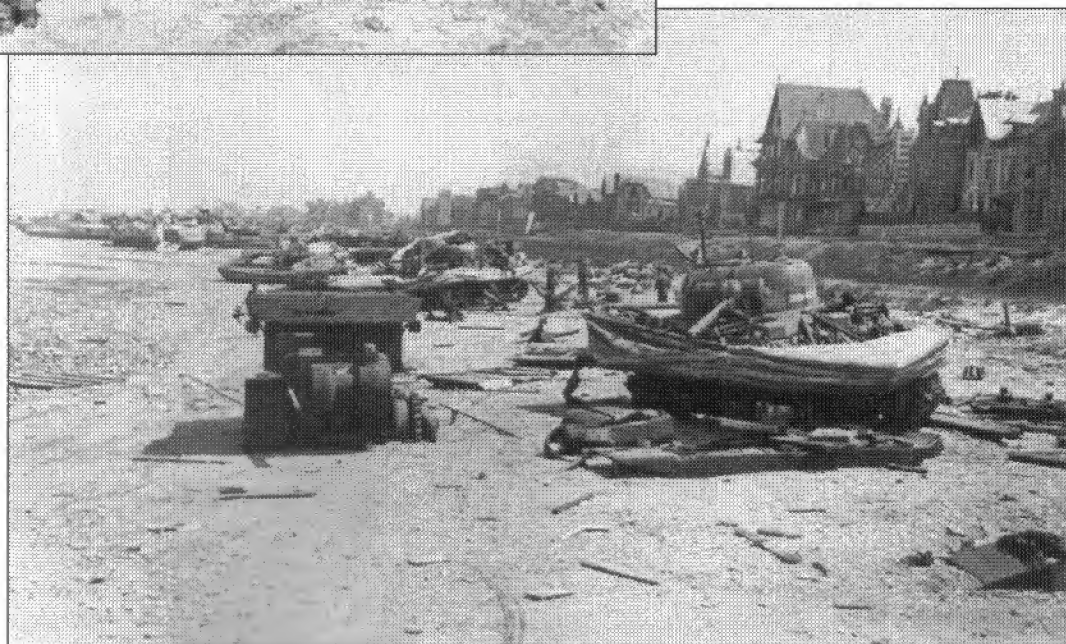
The debris of war still litters Sword Beach near the village of Lion-sur-Mer. In the foreground is a disabled Sherman Duplex Drive, presumably from 13/18th Hussars, and an armored bulldozer. The Duplex Drive Shermans were generally successful in swimming ashore except at Omaha Beach, where the strong wave conditions swamped most of the DD tanks of the 741st Tank Bn. (The Tank Museum)

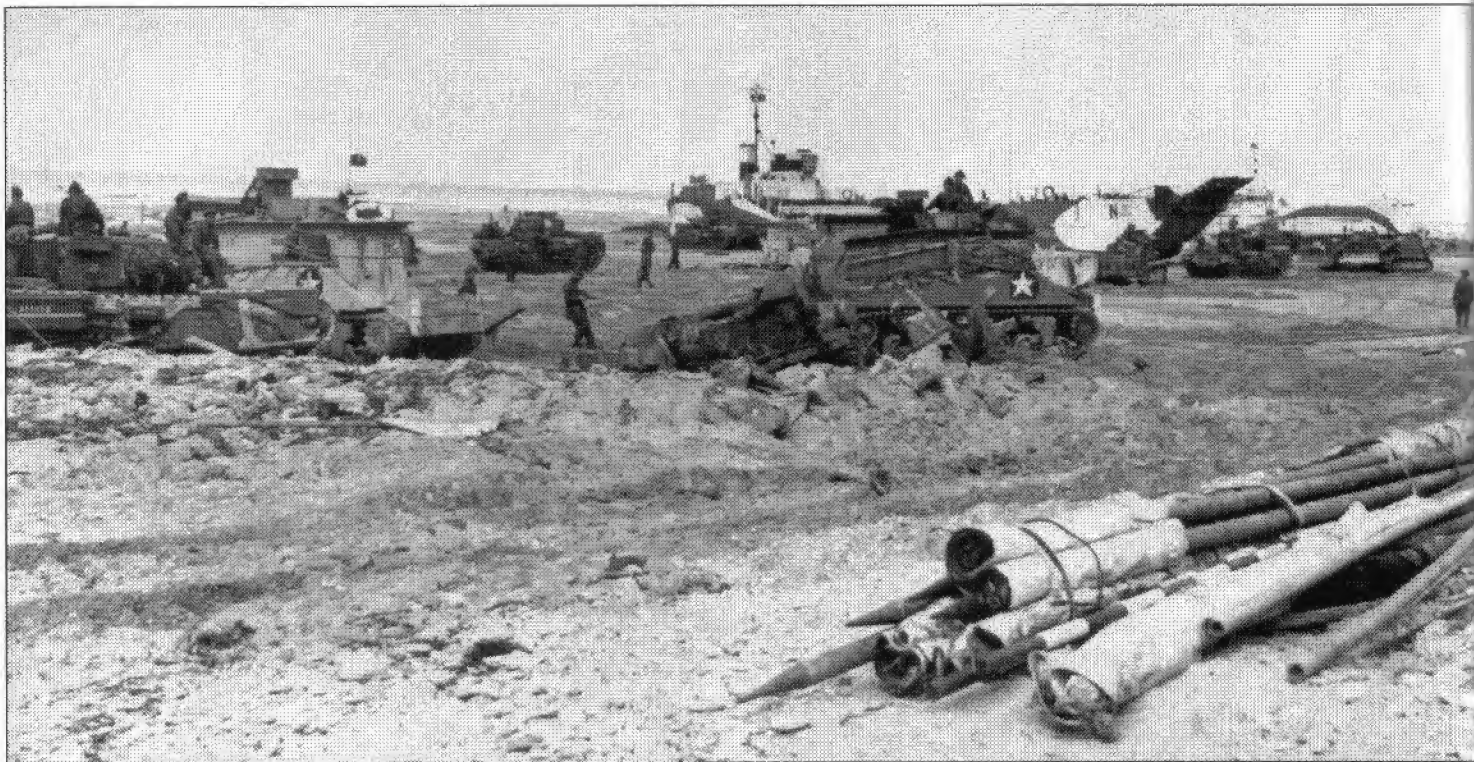
Clean-up activity goes on at one of the British beaches after the landing. The two armored vehicles with prominent white stars are Sherman BARV (Beach Armoured Recovery Vehicles), an interesting British innovation based on the M4 medium tank chassis. A large watertight superstructure was built on the chassis, which allowed the vehicle to operate in the surf to recover disabled tanks and other vehicles. (The Tank Museum)

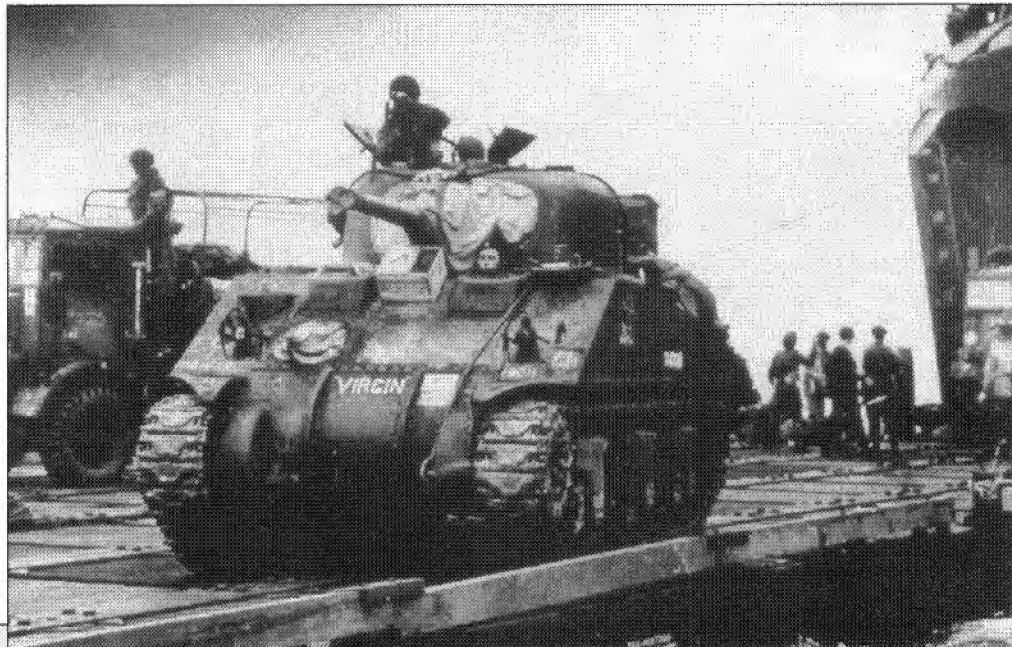
A Sherman V of the 8th Tank Brigade comes ashore via a Rhino several days after D-Day. The Rhinos allowed LSTs to land tanks off-shore without deep wading preparations, and without the need for the ship to negotiate through the obstacle-strewn shallows near the beach area. (US Navy)

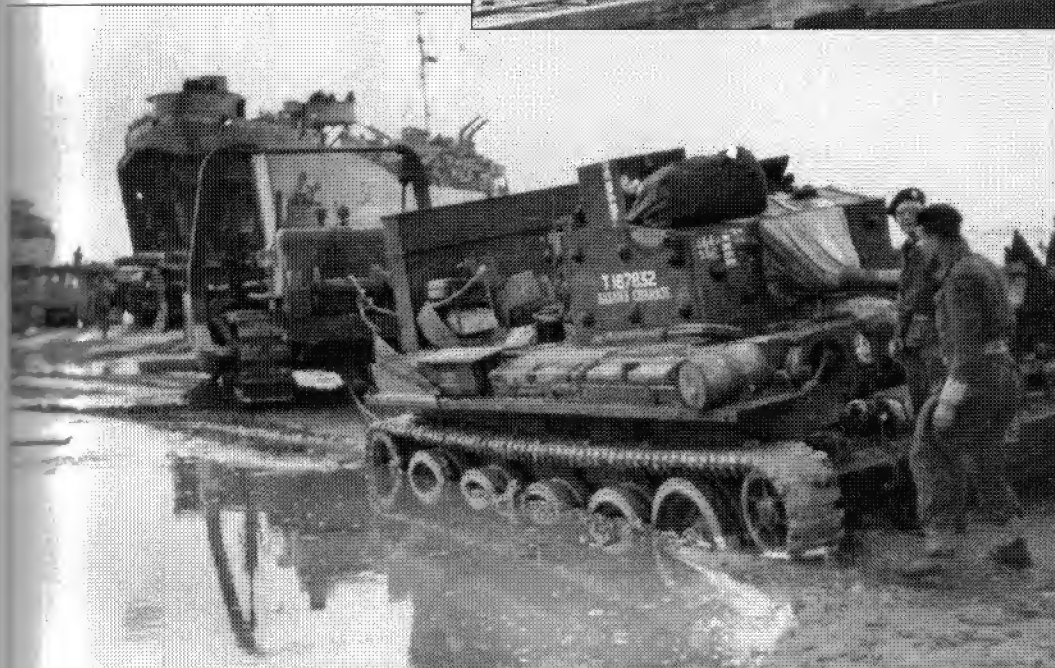
A Cromwell tank named "Satan's Chariot" of the 5 RTR, 7th Armoured Div. bogged down at Gold Beach is recovered by a bulldozer while a LST unloads in the background. This vehicle is fitted with the seldom-seen deep wading trunks used on Cromwells and related cruiser tanks. The 7th Armoured Division was the main armored component of the follow-on forces, landing on 9 June to reinforce the British XXX Corps. (The Tank Museum)

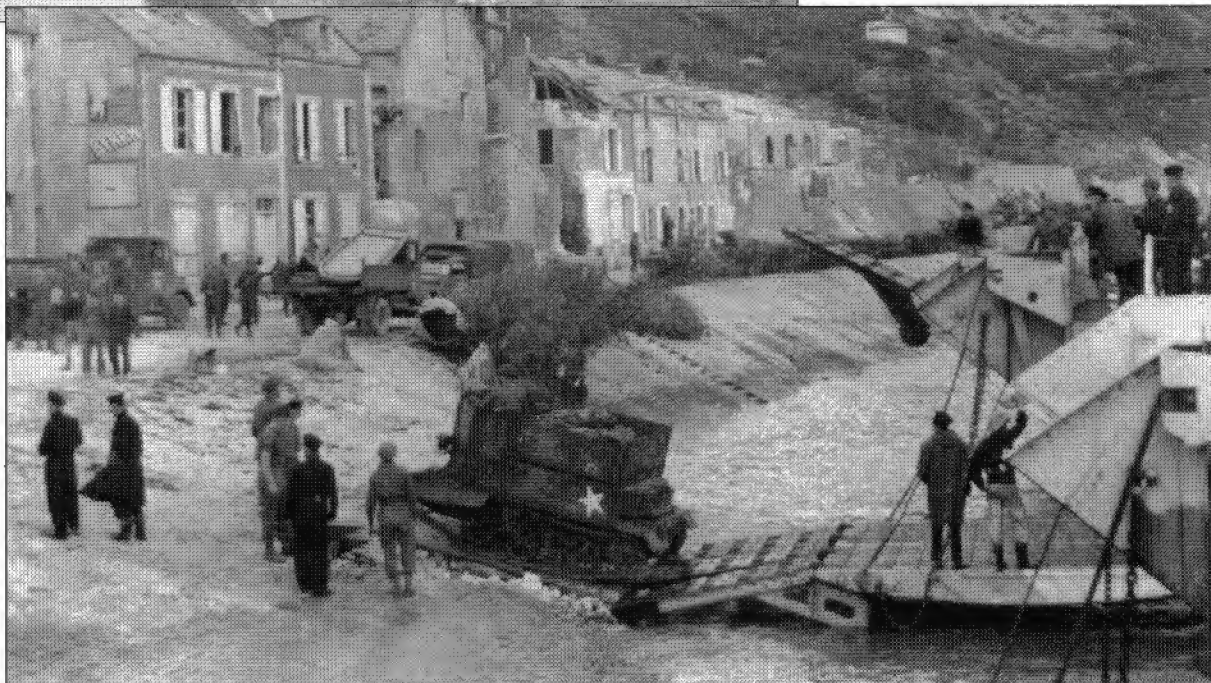
A Deep Wading Universal Carrier comes ashore directly on the beach at high tide from a LCT. Because the Universal Carrier was so low to the ground, a very extensive combing had to be added around the superstructure to allow it to wade in through the surf. The Universal Carrier was the standard infantry vehicle of the British Army in Normandy, but after the July fighting, attempts were made to develop better protected vehicle. (The Tank Museum)

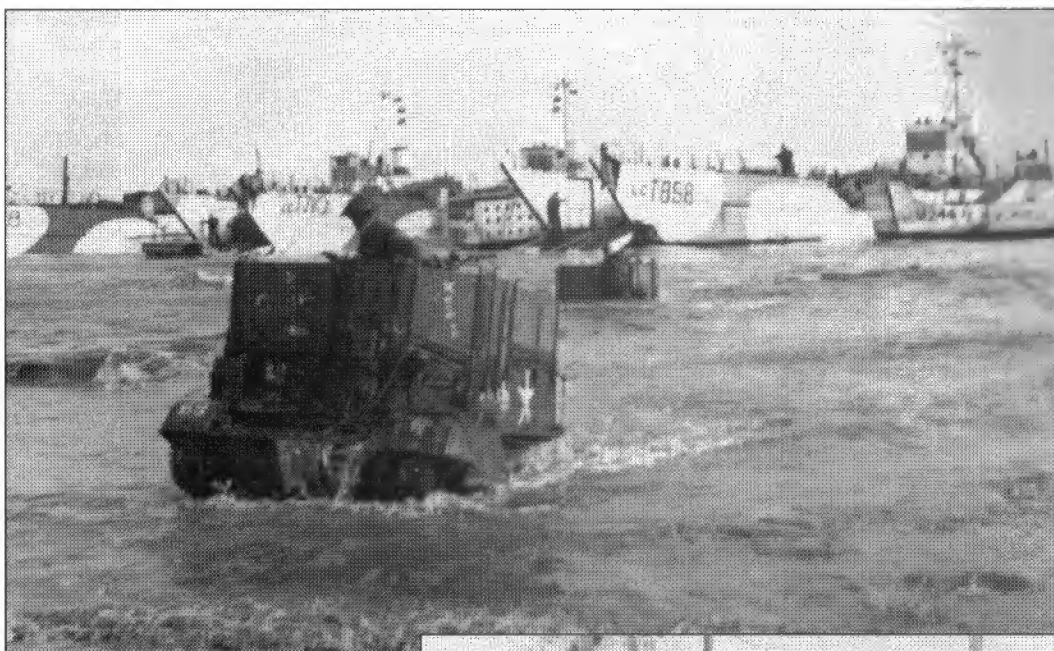
A pair of Universal Carriers of the 50th Northumbrian Division come ashore at Sword Beach from the LCTs behind them. This gives a good idea of why the extensive combing had to be added around the superstructure. (The Tank Museum)

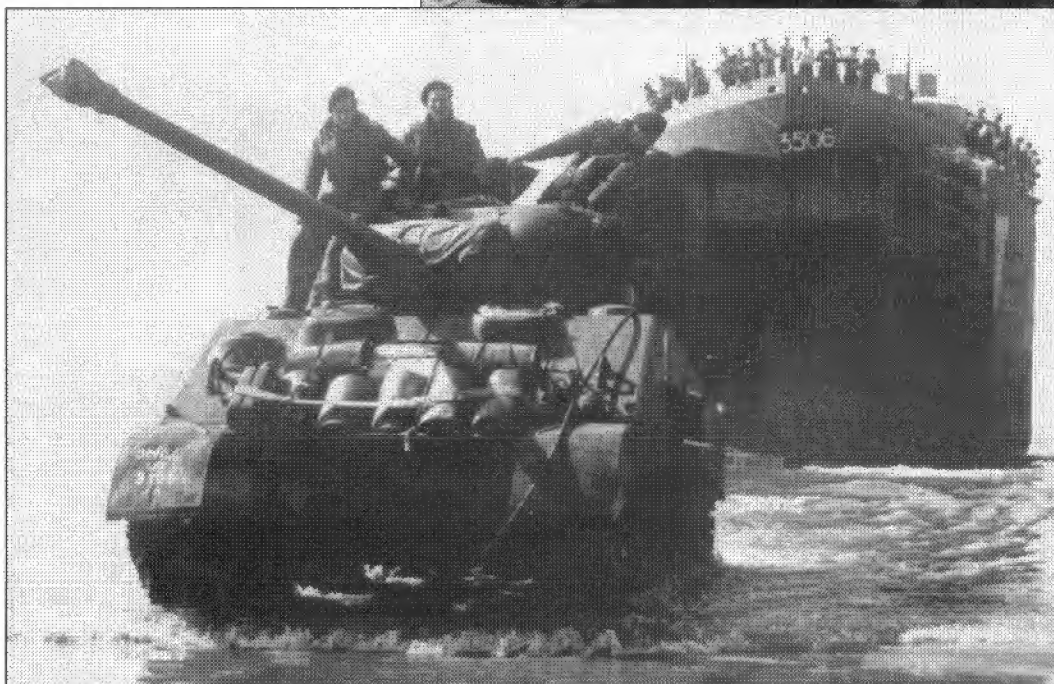
One of the most important innovations in the British armoured divisions was the Sherman Firefly tank, armed with the 17 pdr. This was the only Allied tank able to deal frontally with the heavily armored German tanks like the Panther and Tiger. They were usually issued on a scale of one per troop (one per four tanks) in British, Canadian, and Polish divisions. (The Tank Museum)

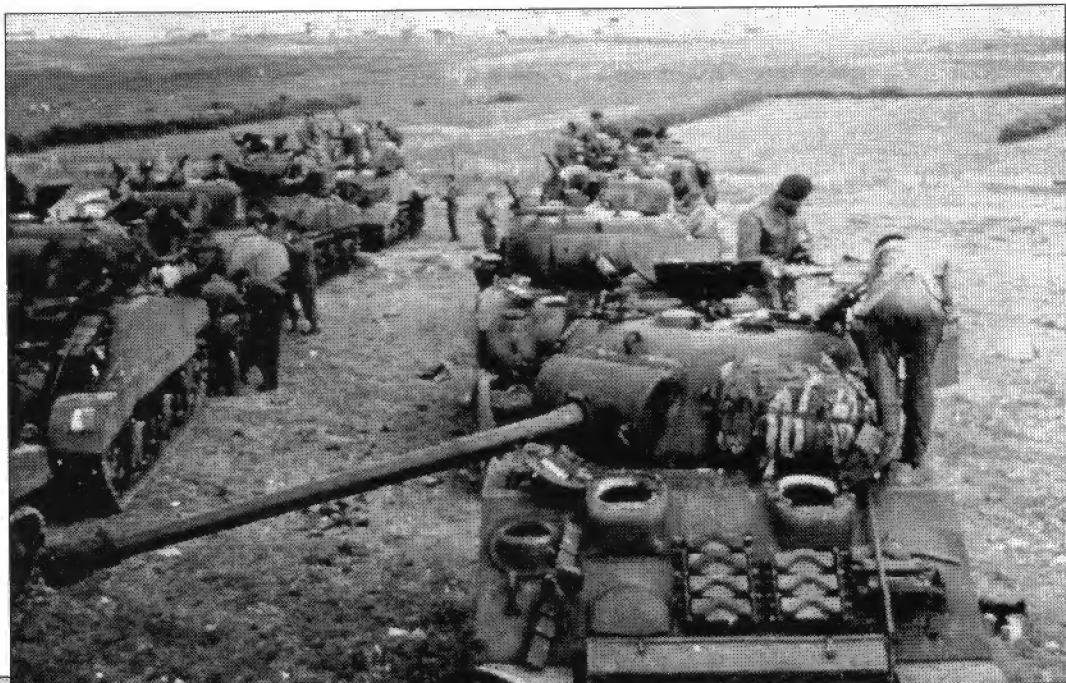
Tankers of the British 4th Armoured Bde., 7th Arm'd Div. prepare their tanks for combat in the fields immediately beyond Gold Beach; the landing area is still evident in the background. The lead vehicle is a Sherman Vc Firefly while the tank behind it is a Sherman II armed with the normal 75mm gun. To accommodate enough ammunition, the Firefly conversion dispensed with the bow machine gun, and careful inspection of the right side of the hull front will reveal that the machine gun position is plated over. (The Tank Museum)

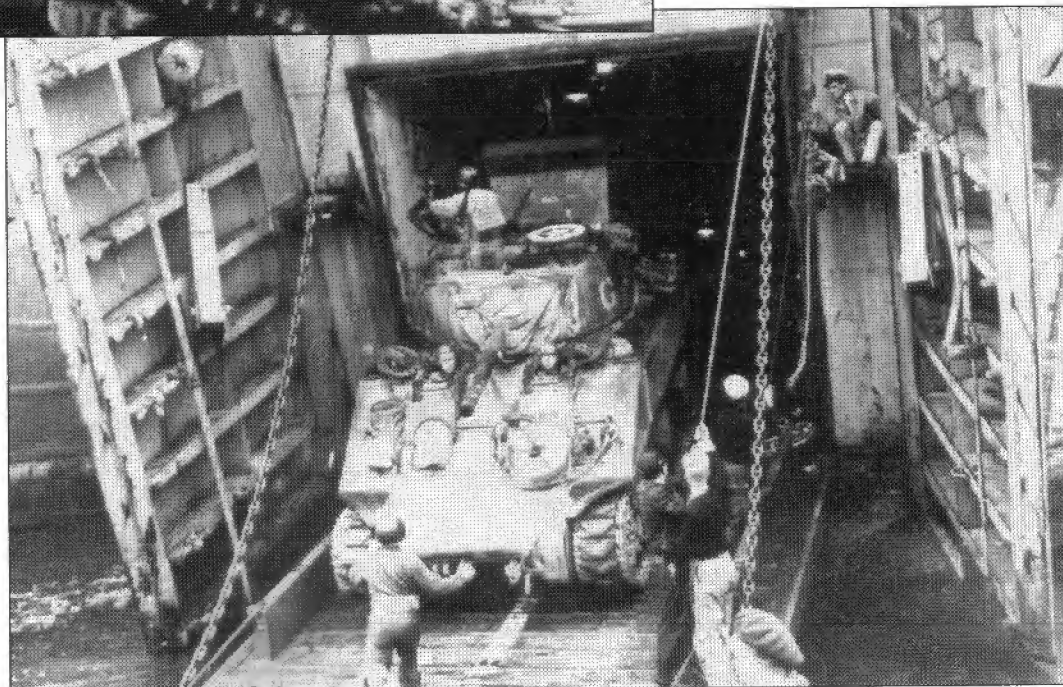
"Hurricane", a M4 medium tank with wading trunks of Co. H, 66th Arm'd Regt., 2nd Armored Division comes ashore from an LST at Utah beach on D+1. The 2nd Armored Division was the first US armored division ashore, and landed beginning on the second day of the landings. This gives a very good view of the circled white star used by the Allied forces on all armored vehicle for air identification; it was often repeated even larger on the engine deck. By July, it was being replaced by fluorescent cloth identification panels, as the marking was not distinctive enough to fast-moving Allied aircraft. (US Navy)

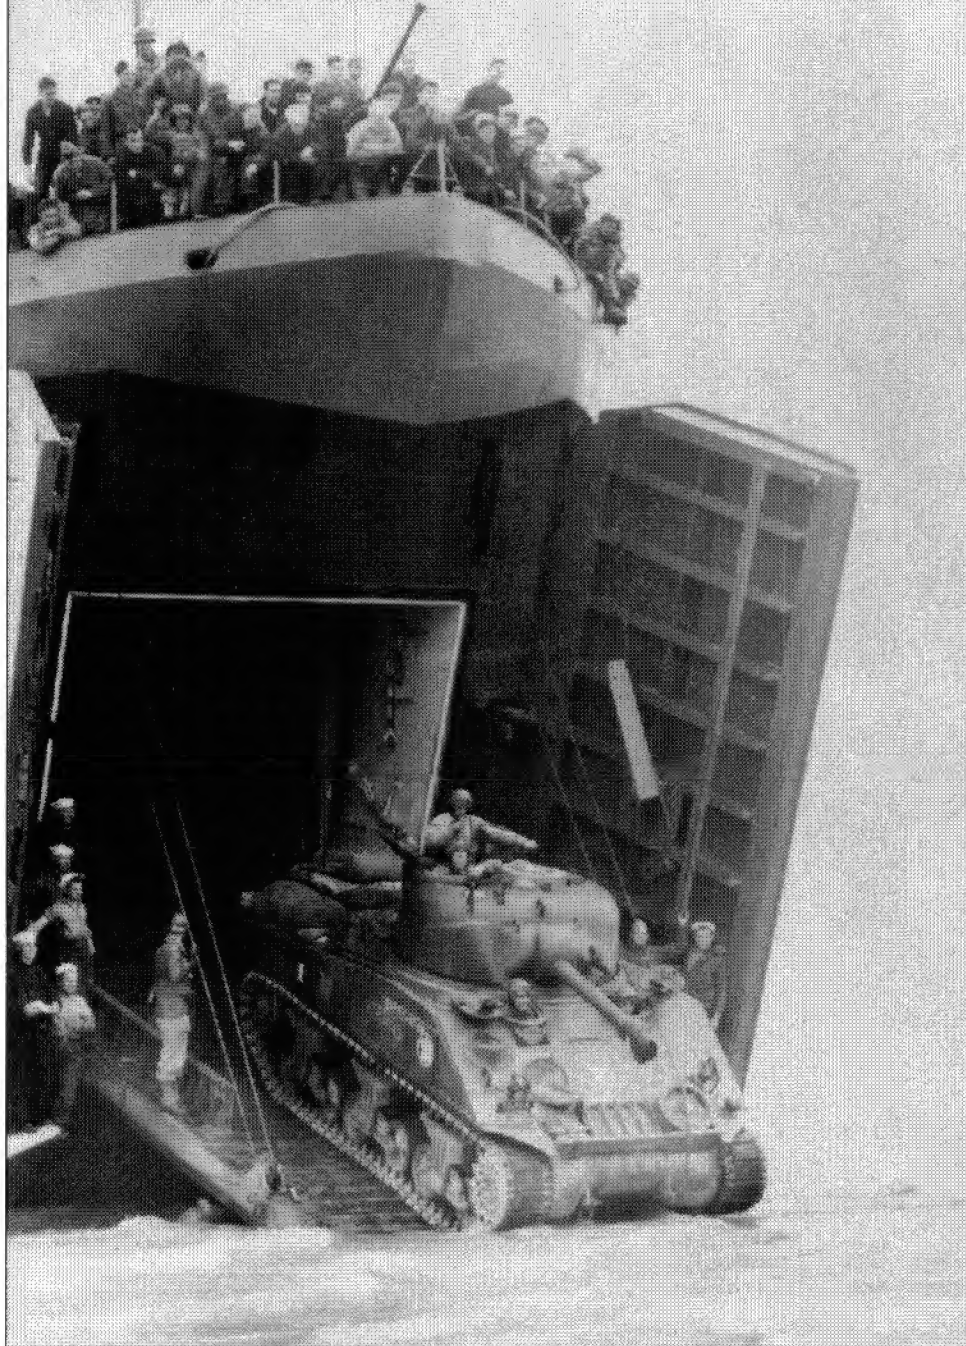
A M4 of Co. G, 66th Arm'd Regt., 2nd Armored Div. unloads from an LST at Utah beach on D+1 or D+2. All of the tanks of the 2nd Armored Div. were waterproofed with deep wading gear, as it was not known how soon clear channels could be opened past German beach obstructions to allow the larger LSTs to approach the beach. However, Army engineers and Navy Seabees were able to clear channels by the end of the D-Day.

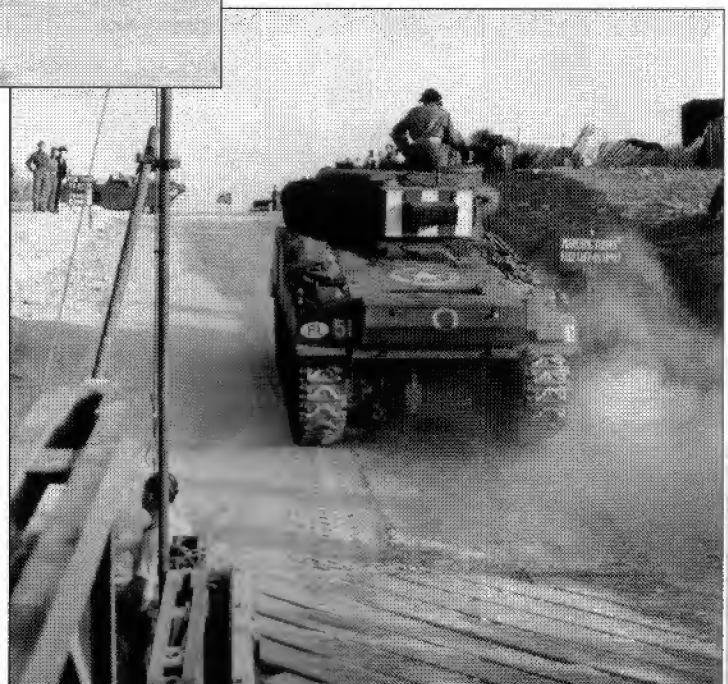
Another of the tank units landed to assist in the breakout operations was the French 2nd Armored Division, which landed at Utah Beach on 1 August. This is a M4A2 tank named "Pertrous" from the 12e Regiment de Chasseurs d'Afrique. Careful inspection of the right headlight framing will reveal a "SOMUA" plate, a reminder that many of these tank crews had served on a SOMUA 35.S tank when first stationed in French North Africa. (US Army)

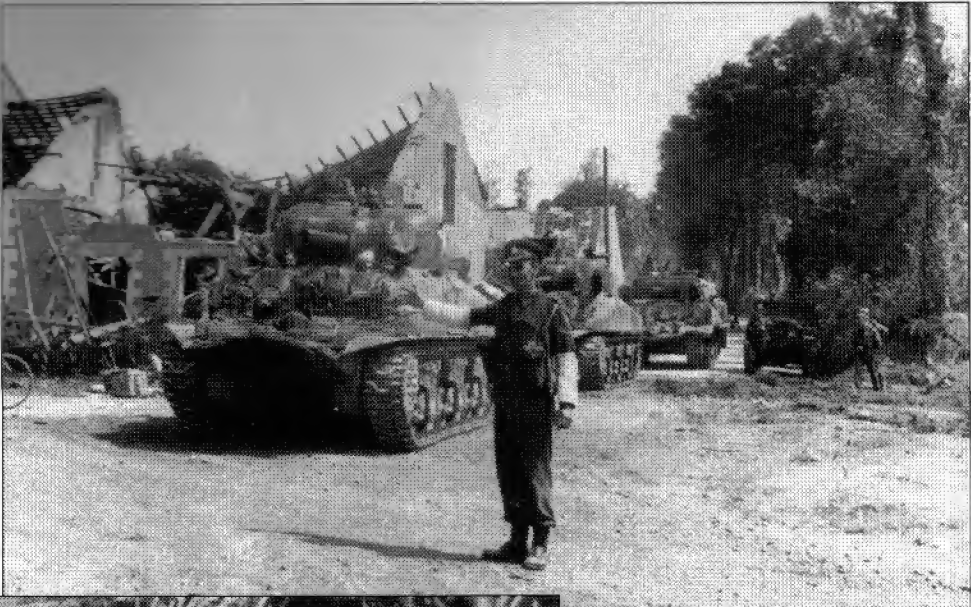
Once free of the beaches, the Duplex Drive Shermans shed their swimming skirts, as we see on this column of British Shermans passing through Douet. The DD tanks often retained the metal framing for the skirts, making them identifiable even with the skirts removed. (The Tank Museum)

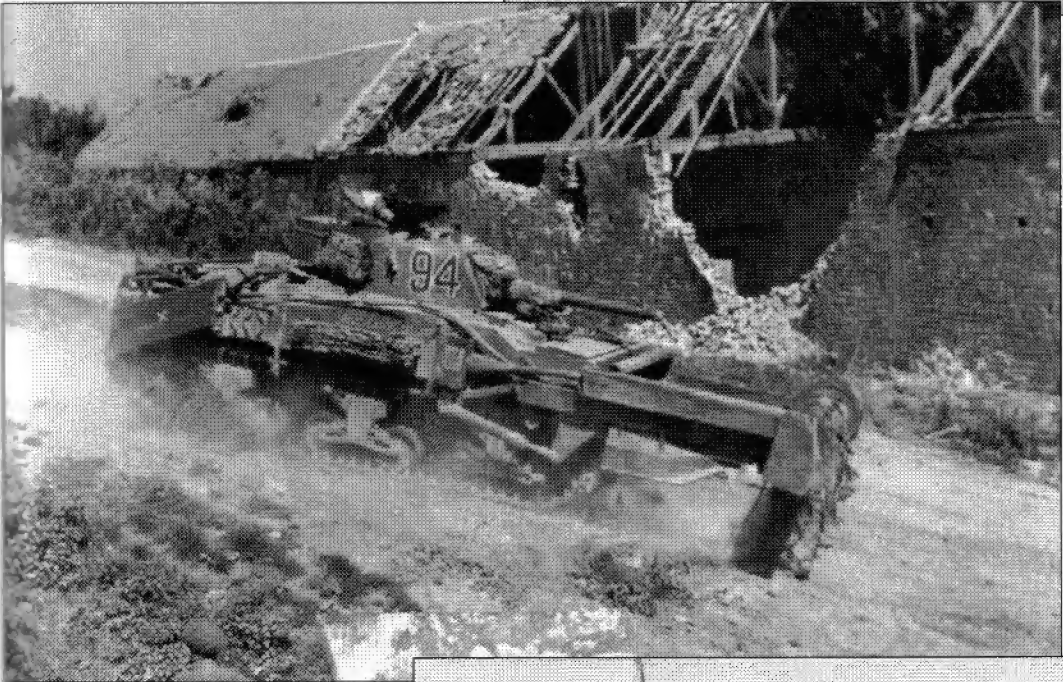
The Sherman Crab was another British innovation that was widely used during the Normandy operation. The Crab was another Sherman engineer modification with a mine flail attached at the front. The large structure continued the powertrain which spun the flail chains in front of the tank which detonated mines. The device at the rear of the tank dropped lane markers to identify cleared areas. British flail tanks had been employed since the North African campaign and continually refined. (The Tank Museum)

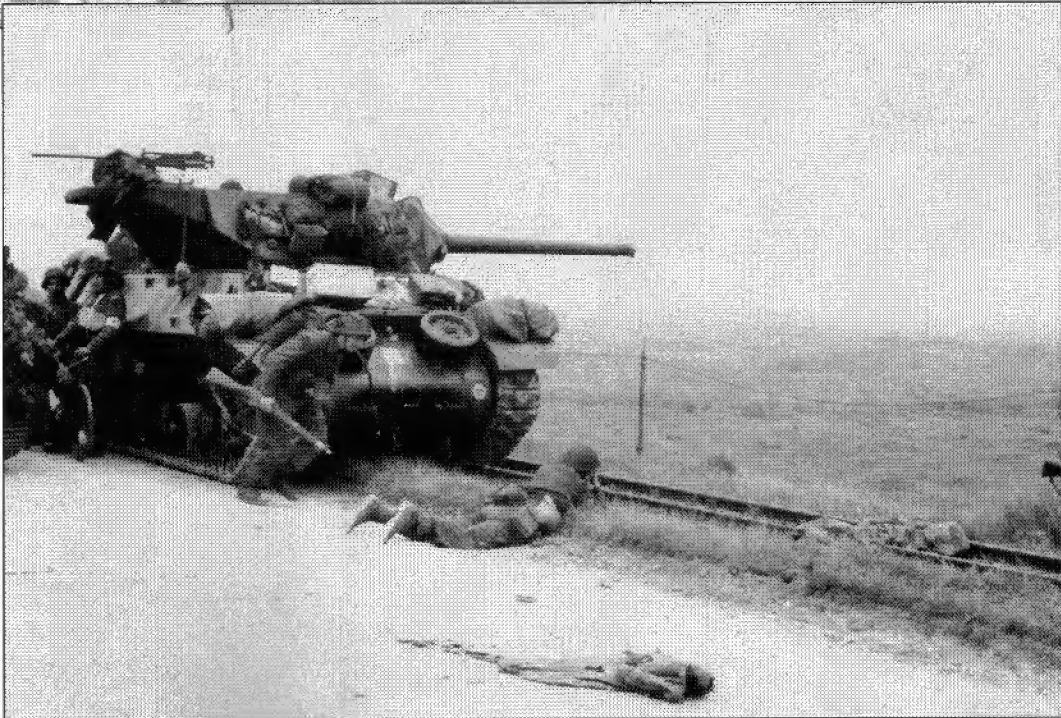
A M10 Achilles Mk. II engages German snipers while supporting 3rd Division infantry in early June in the area beyond Sword beach. The Achilles was the British name for the American M10 tank destroyer; the Mk. I was the early version with the triangular rear turret counter-weights, the Mk. II referred to the enlarged turret with the "duck-bill" counterweights at the rear of the turret. (The Tank Museum)

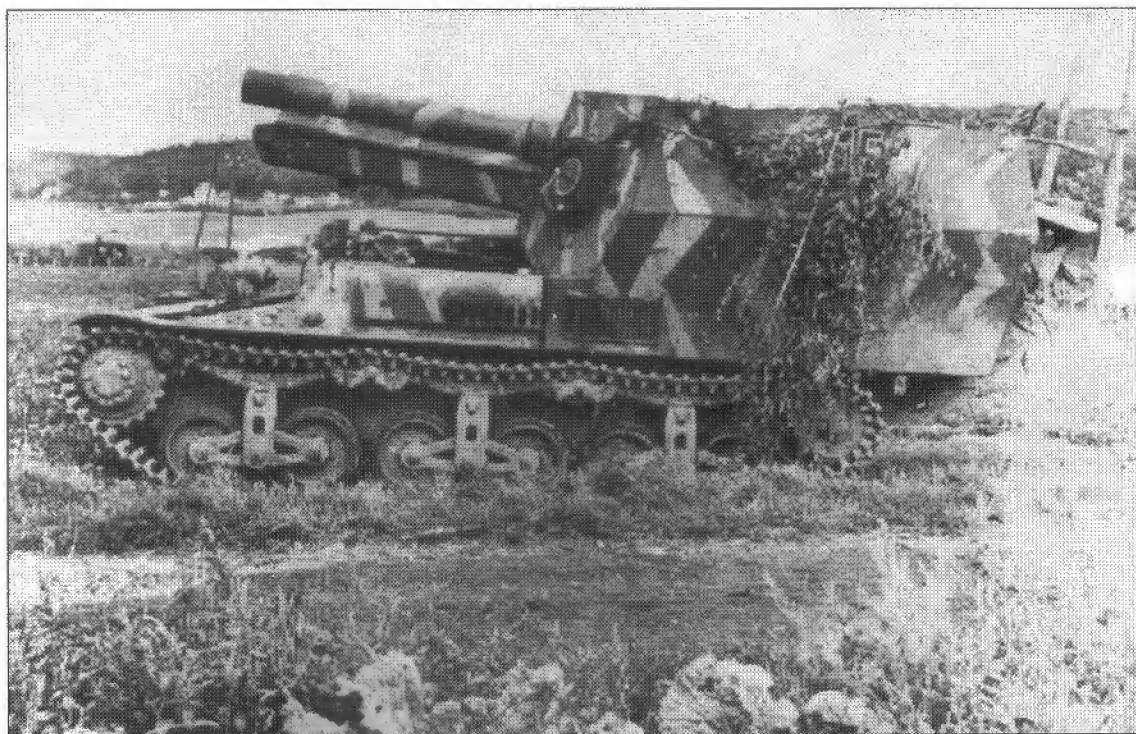
One of the more widely traveled of the Becker conversions was the 15 cm-sFH 13/1 auf Geschutzwagen Lorraine-S (f) Sd.Kfz. 135/1 which consisted of a German World War I-vintage 150mm field howitzer mounted on a French Chenillette Lorraine armored transporter. A total of 72 of these were built by the Baukommando Becker in Paris, and some served with 21. Pz.Div. in the North African campaign. In 1943, the survivors equipped the "Verstärken Schnellen Brigade West" and in the summer of 1944, 45 were attached to the Pz.Art.Rgt. 155 of 21.Pz.Div. along with 43 similar conversions on Hotchkiss light tank chassis. This vehicle, captured by the US Army, has a particularly elaborate splinter camouflage. (US Army)

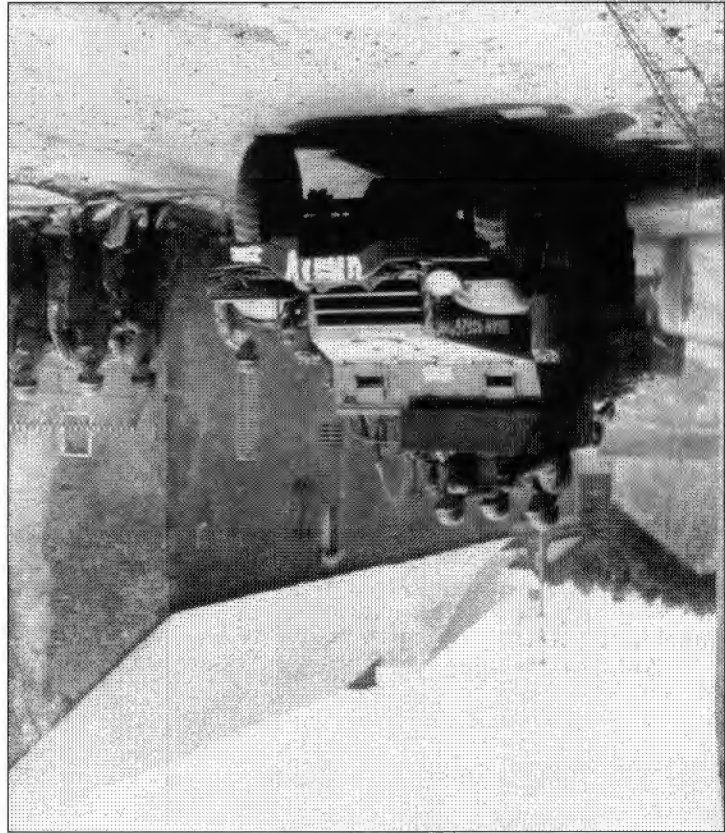
The Canadian built Ram tank, a contemporary of the early Sherman, never saw combat in Canadian tank units, but small numbers were used in self-propelled artillery regiments by troop commanders in lieu of Shermans as the Ram OP. The Ram's main falling was that by 1944, its 6 pdr. main gun was inadequate and Shermans were available in sufficient numbers to equip the Canadian armored units. The RD insignia evident on the gun mantlet indicates that this is a tank of the troop commander of D Battery; the Ram of the gun position officer would be marked with a GD. (Public Archives of Canada)

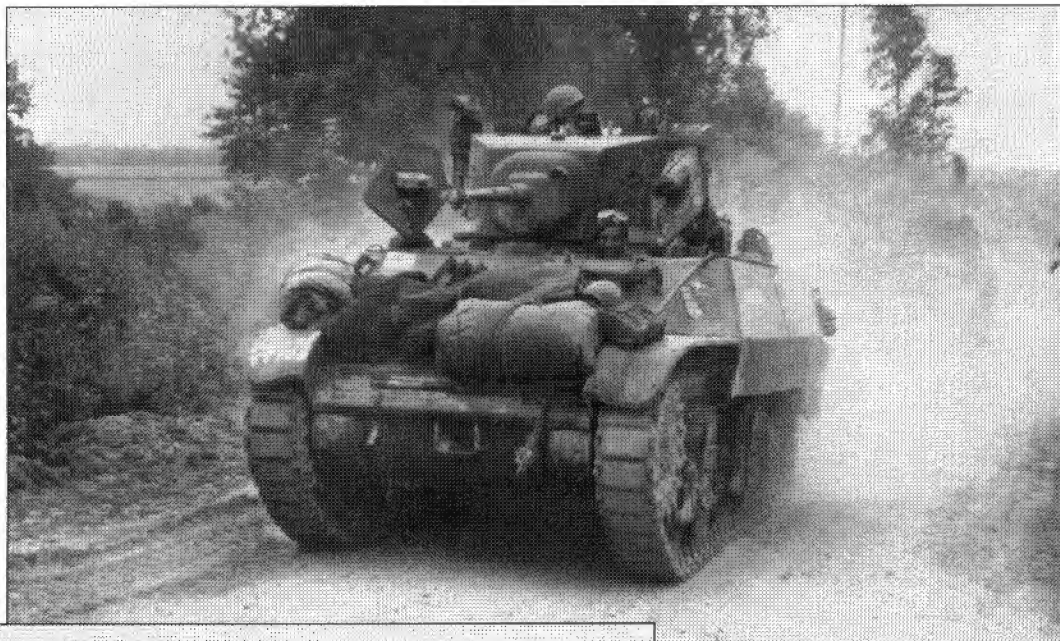
The standard recon tank in the British armoured divisions in Normandy was the Stuart V (M3A3), seen in action on 15 June near Bayeux-Tilly with the 1st Armoured Division. The division's legendary Desert Rat insignia can be clearly seen on the upper right corner of the glacis plate in front of the co-driver position. Although automotively improved over the Stuart versions used in North Africa, its firepower was no better. (The Tank Museum)
